Test Intention:

In test 4876 we want to compare the lifespan of our TPE cable CF9.15.18 and a PUR competitor cable. The CF9 is declared for use at -35°C in e-chain application and the competitor for flexing at -40°C.

e-chain® type: E4.28.50.100.0

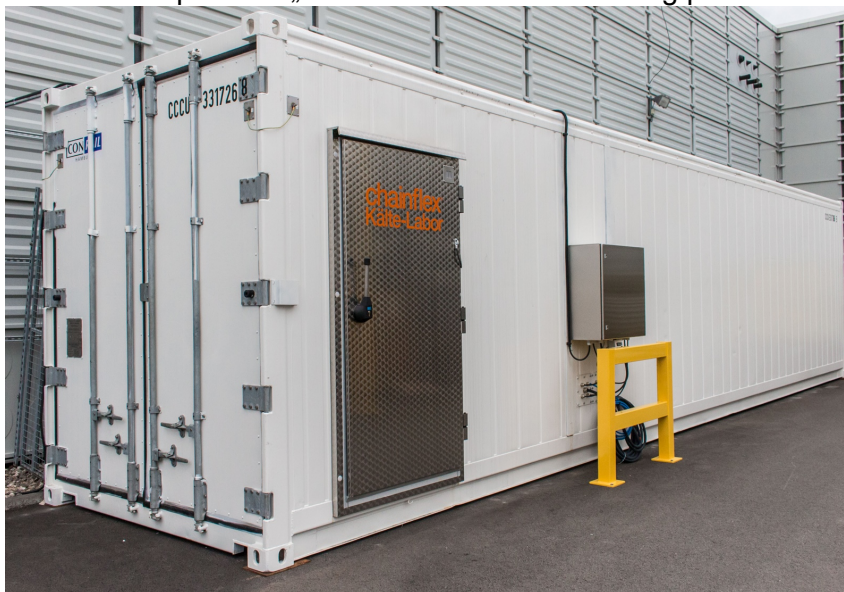
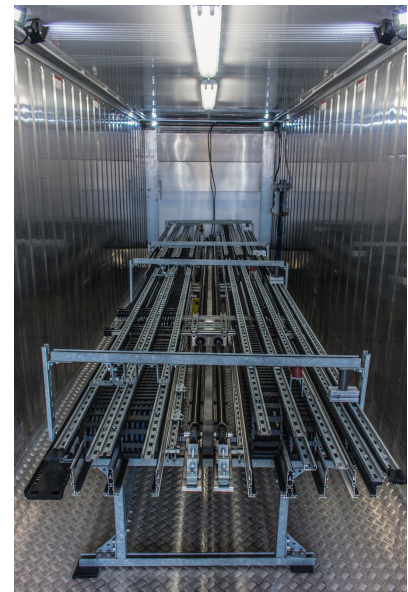
This test is built up on the „Klimakammer“. The following picture shows the test structure:

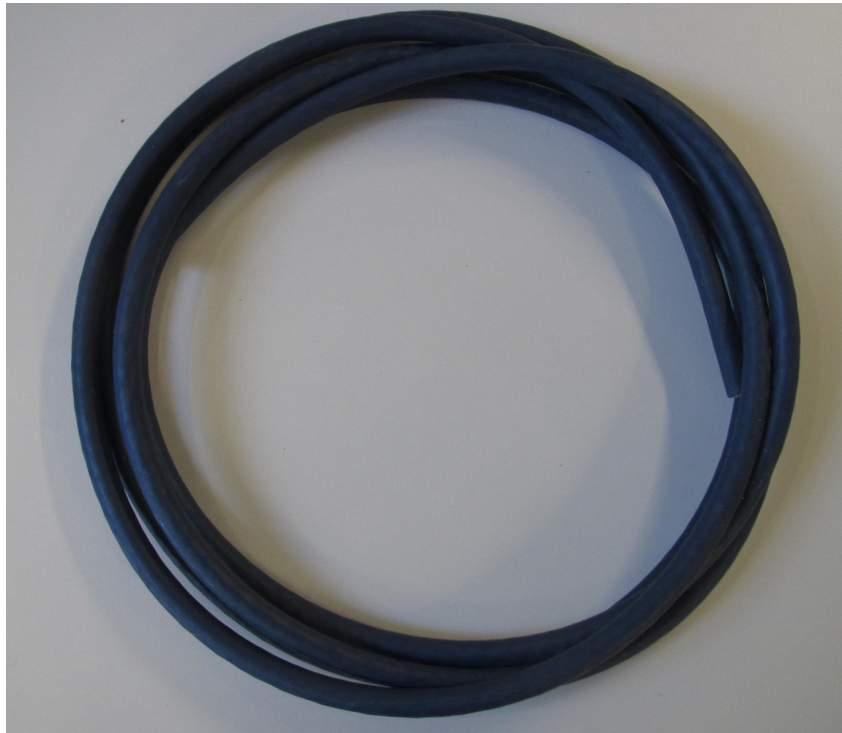
The condition of the cable no.1.1 (CF9.15.18) after 526.775 double strokes

At the 01.07.2014, after 526.775 double strokes we demounted the cable to finish the test. Cable no. 1.1 showed no damages, the outer jacket is still in a good condition

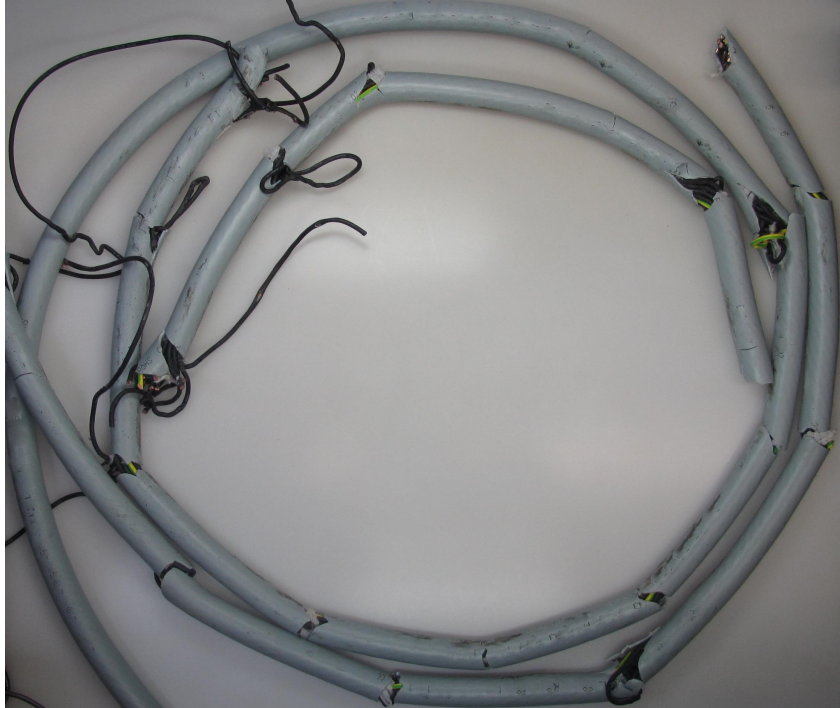
The condition of the cable no.2.1 (Competitor) after 40.533 double strokes

... after less than 41.000 double strokes at -40°C with approx. 6,4xd!

We demounted the cable no. 2.1 after 40.533 double strokes, because we noticed several breakages on the outer jacket.
